French Limited Wetlands Mitigation

Site Selection Report

**Crouch Environmental Services
12115 Wessex, Suite 100
Houston, Texas 77089
(713)579-2565**

April 25, 1994

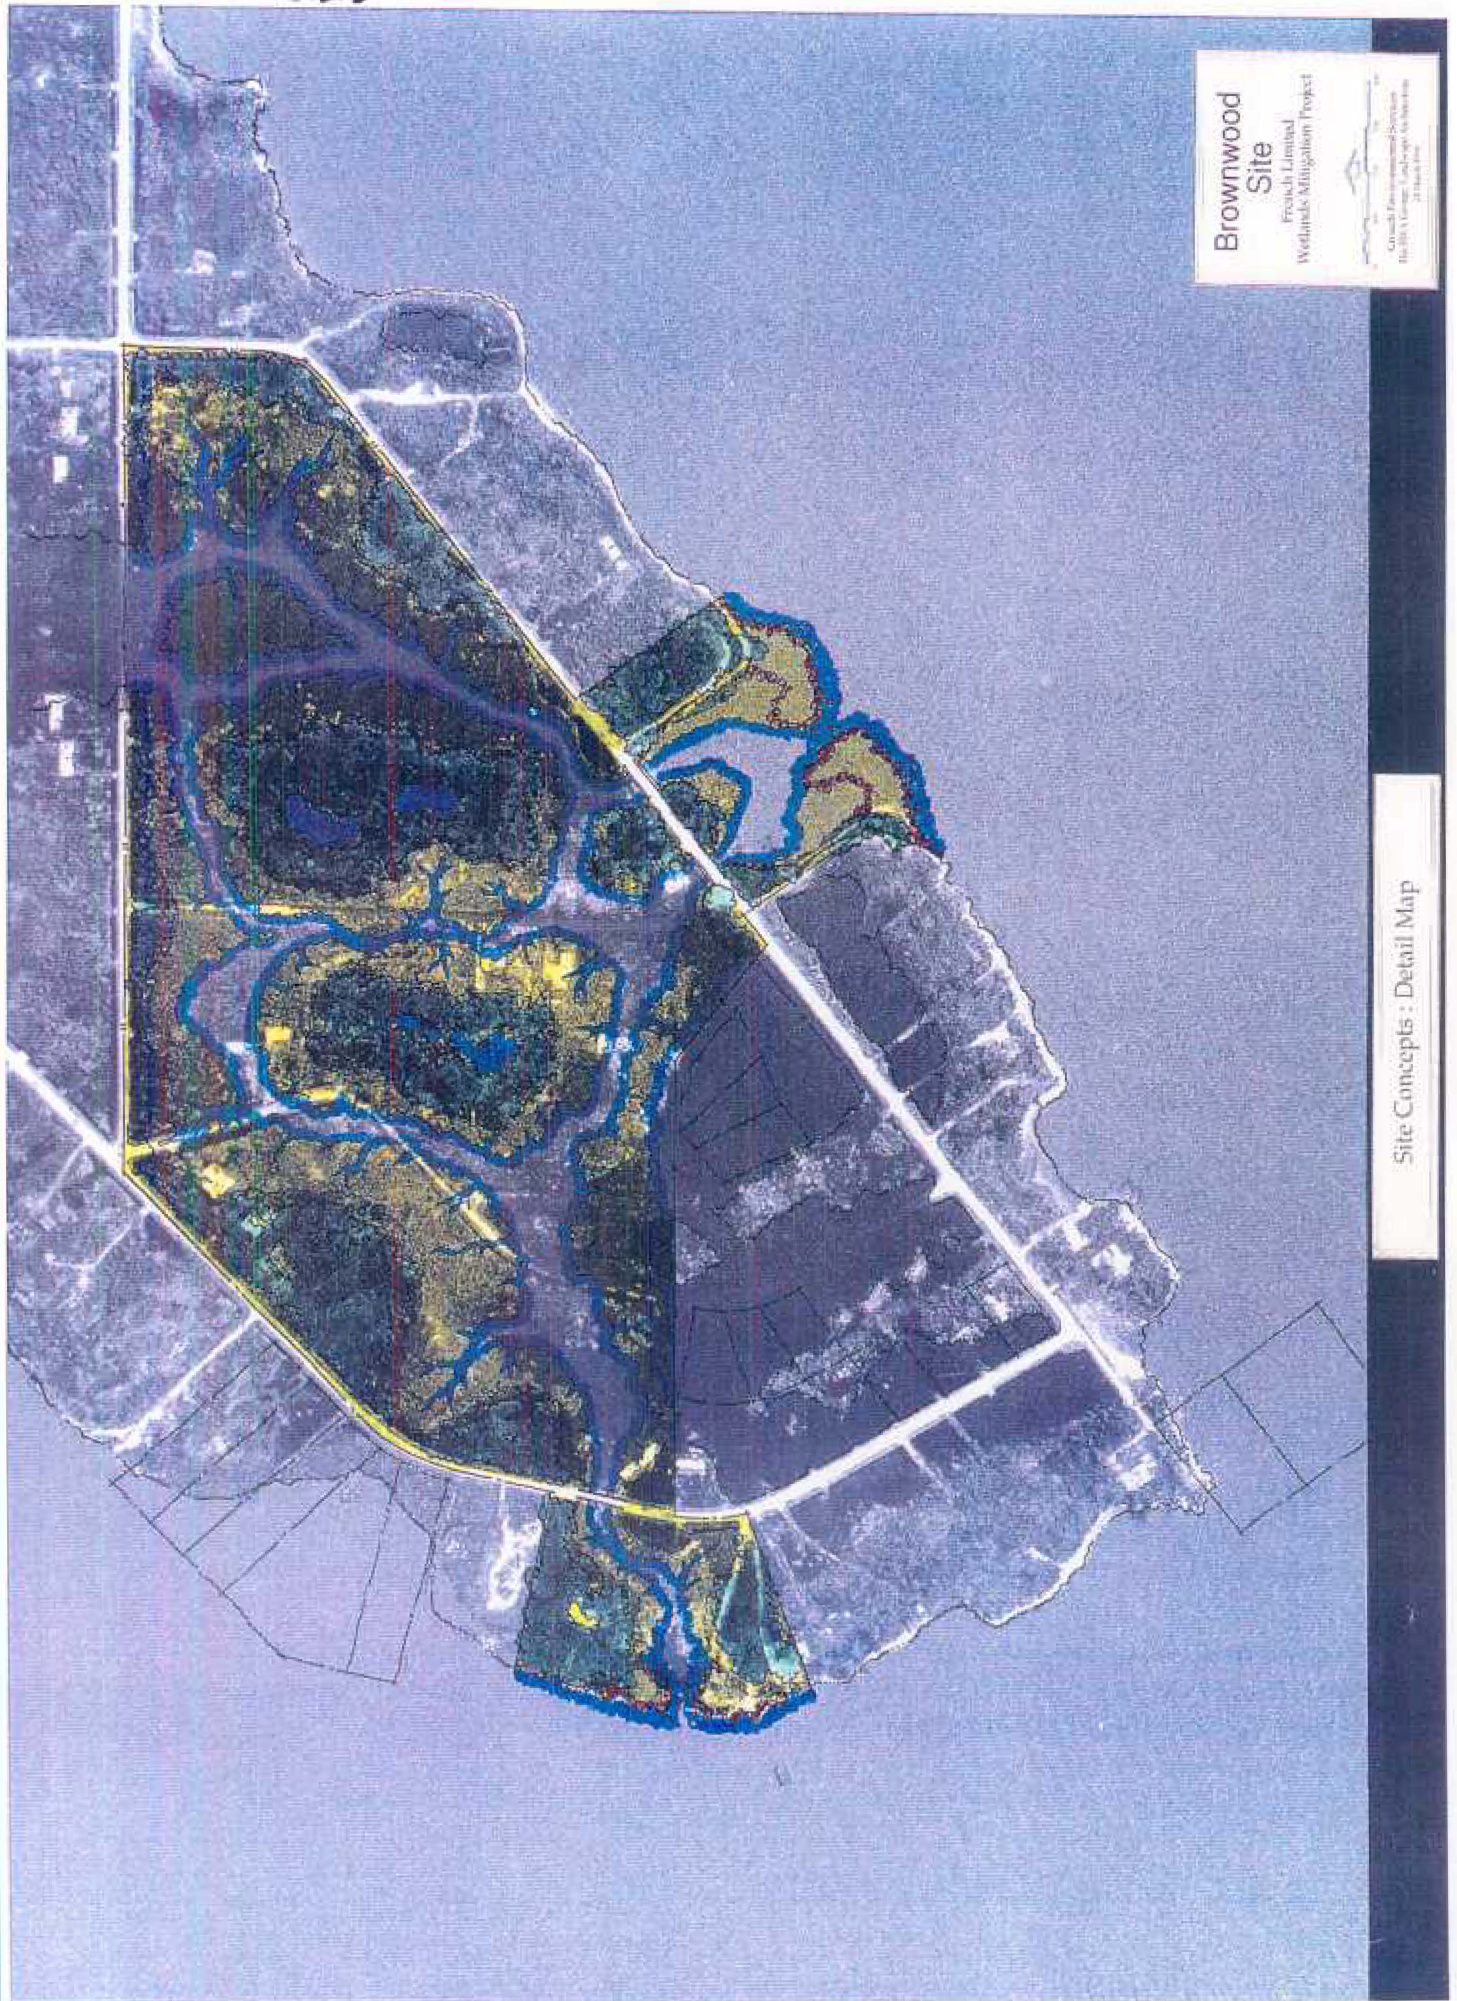
Figure 3

Analysis of this design indicates that the entire project would develop 59.8 acres as follows:

Marsh Grass Zone	20.8 acres
Open Brackish Water	16.8 acres
Upland Edge	8.0 acres
Woodland	13.4 acres
Fresh Water Pools	0.8 acres
TOTAL	59.8 acres

While some shoreline stabilization is shown on the preliminary design for the Brownwood Site, it was found that sufficient acreage exists inside of the road looping the site to build the project. As a result, the existing shoreline would serve as a wave barrier and would provide sufficient protection for the new wetland. Because of this, more of the construction budget could be devoted to the creation of valuable wetland habitat at Brownwood rather than being devoted to construction of physical structures required to control natural forces.

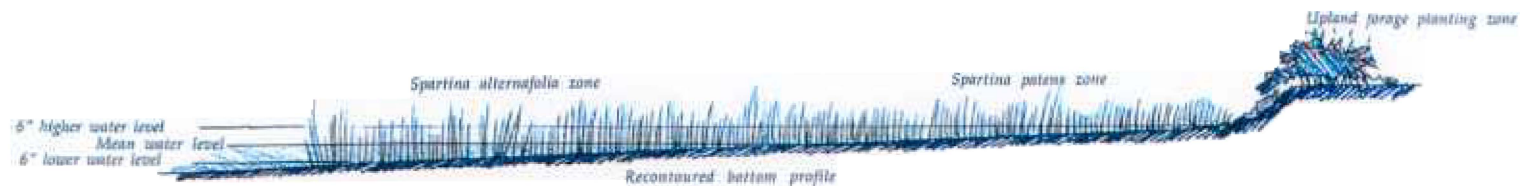
DETAIL TYPICAL SECTION

Figure 3 depicts a revised preliminary conceptual design for the wetlands project at the Brownwood Site. While preliminary, this design shows that the project can be developed in accordance with the criteria of the Consent Decree utilizing land that City of Baytown has agreed to make available to FLTG. This property is within the loop road inside Brownwood, protected from wave stress. Figure 4 presents sections further illustrating the conceptual design.

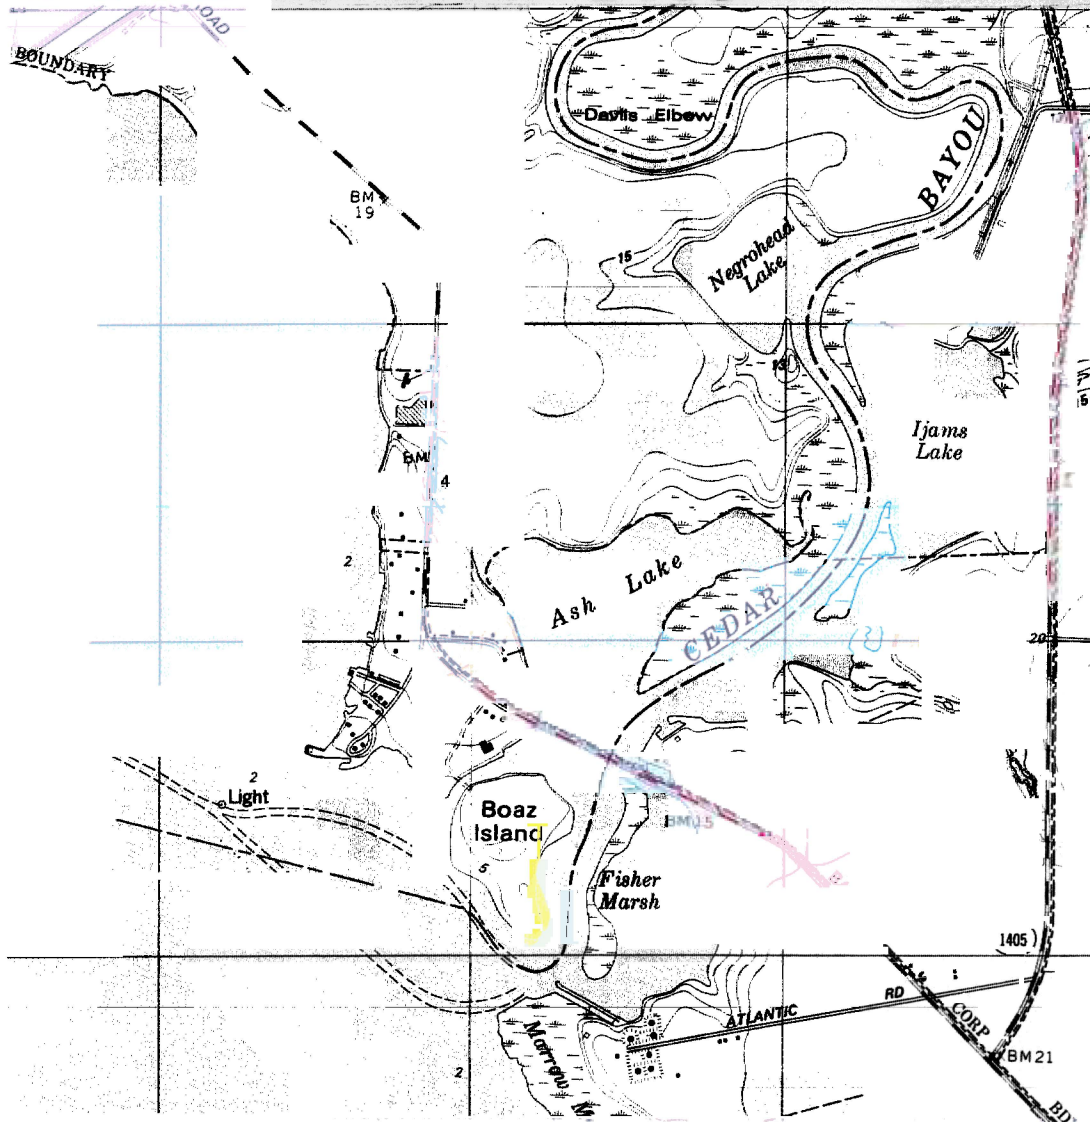
Boaz Island Site

Characteristics:

**Highly
inaccessible**

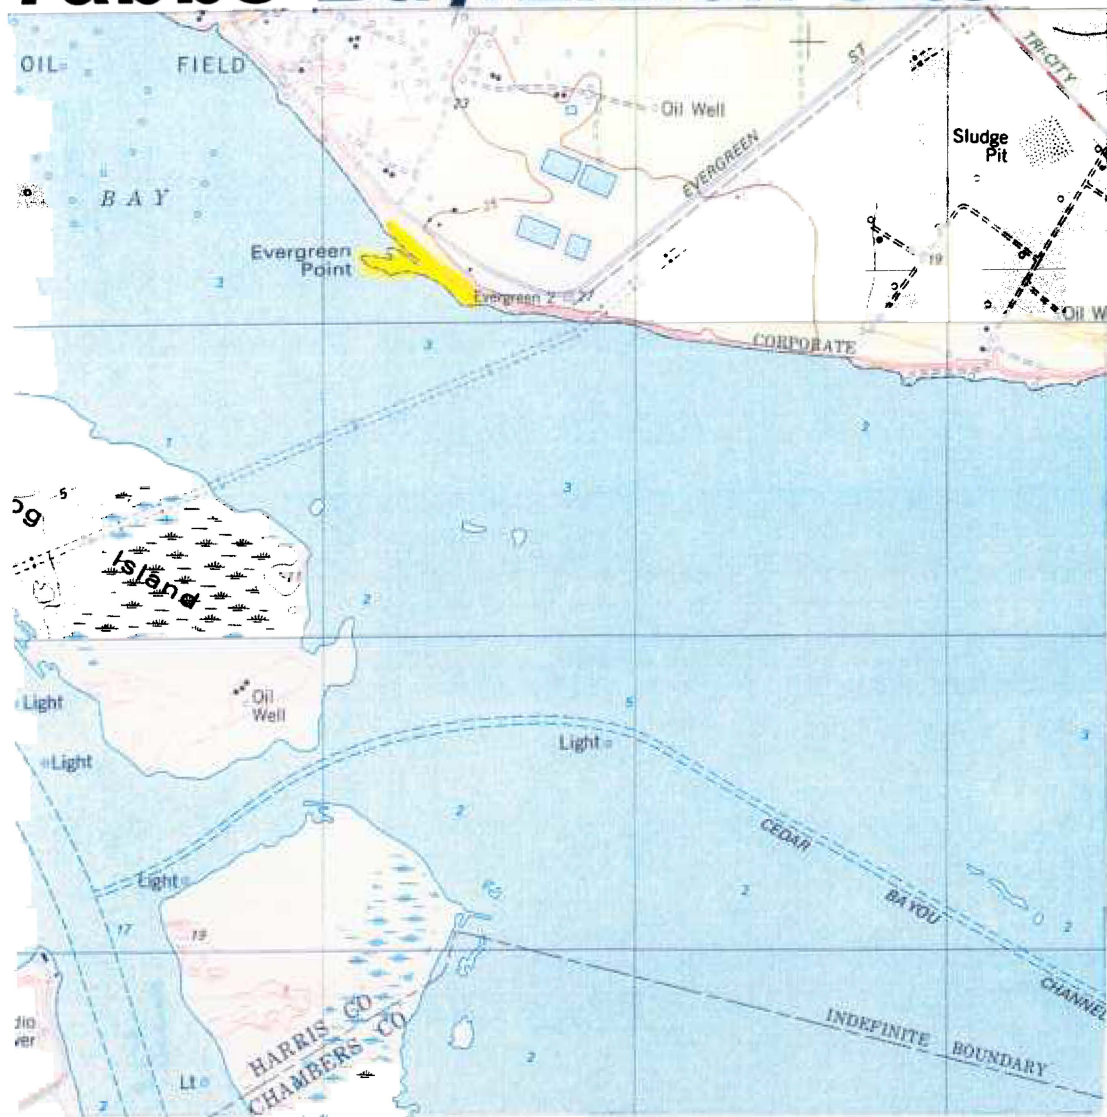
Tabbs Bay/Exxon Site

Characteristics:

- **USFWS wants edge cleaned up and enhanced**
- **Steep banks - lots of excavation to create additional wetland acreage**
- **Good access**
- **High wave stress**
- **Near subdivision**
- **Many working wells in bay**

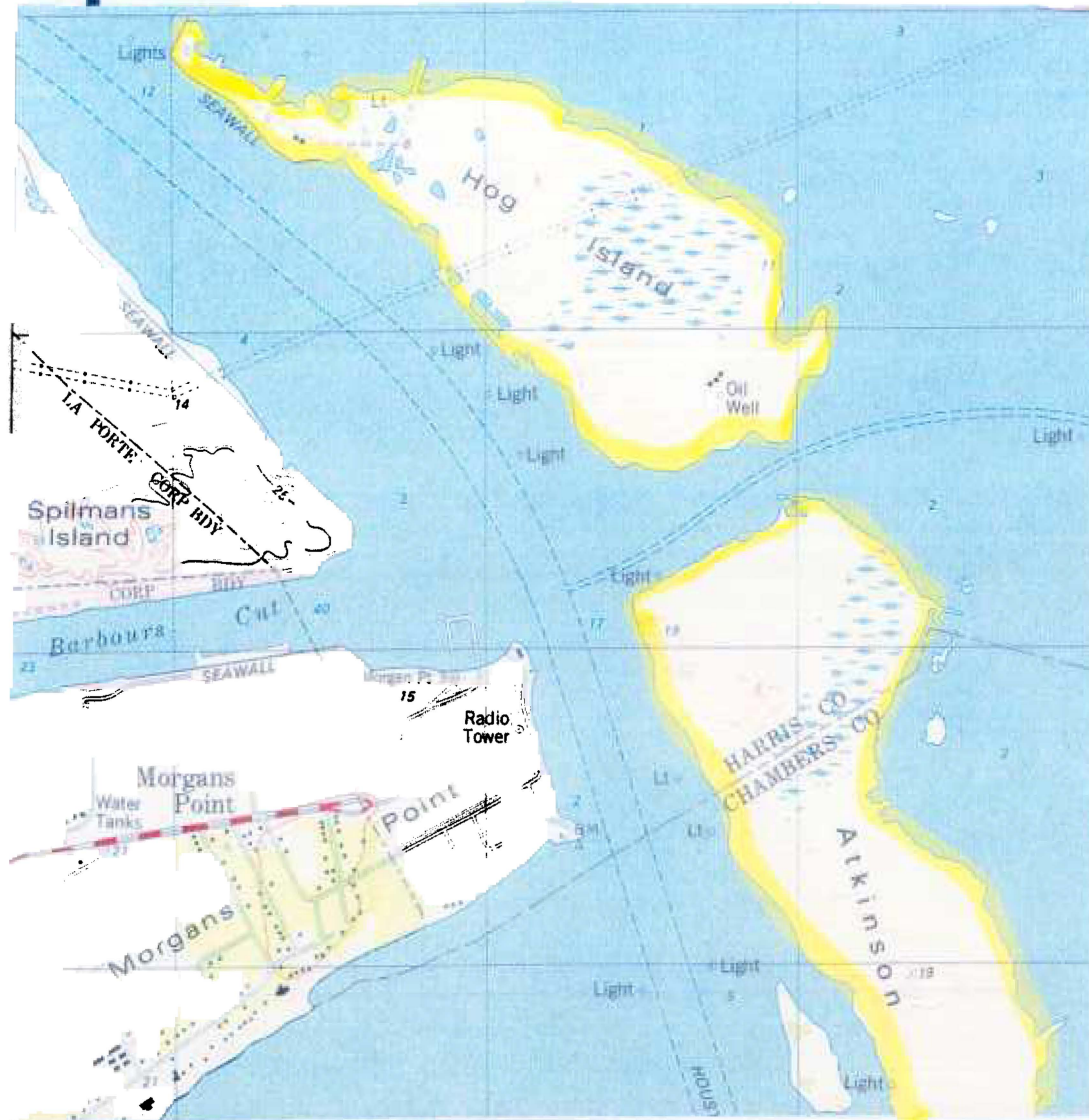
Spoil Islands

Characteristics:

- No public access
- High wave stress
- Difficult access for construction equipment
- Built through dredged spoil deposition
- Easily enhanced
- Large amount of acreage available

The public would have virtually no access to the Spoil Islands. That factor, coupled with difficult construction and high wave stress, caused this site to be eliminated in favor of others.

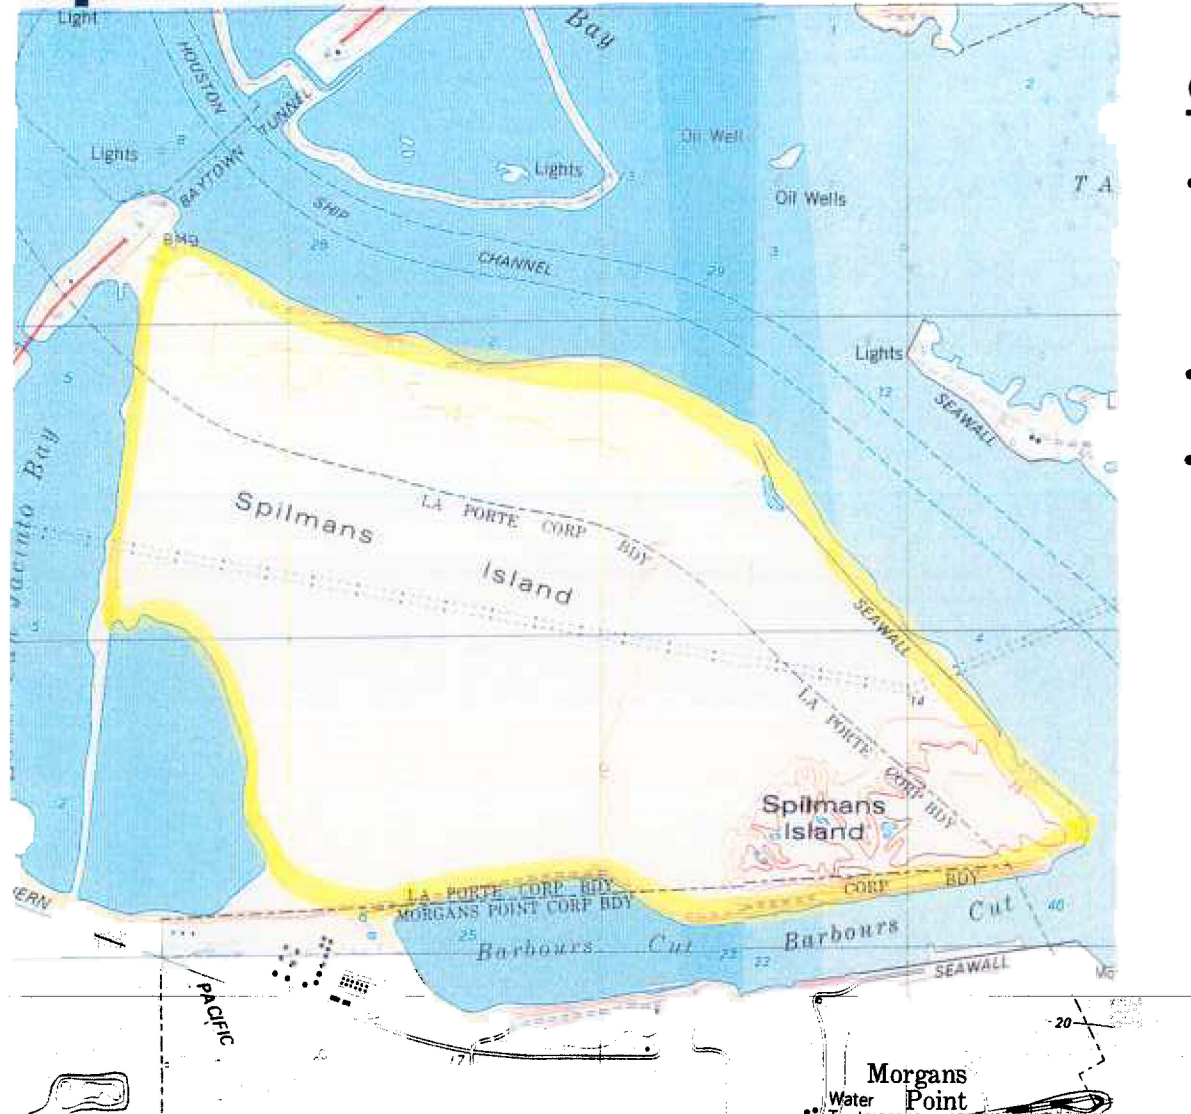
Spilmans Island Site

Characteristics:

- Apparent on-going spoil deposition
- Inaccessible
- Does not appear to be a suitable site

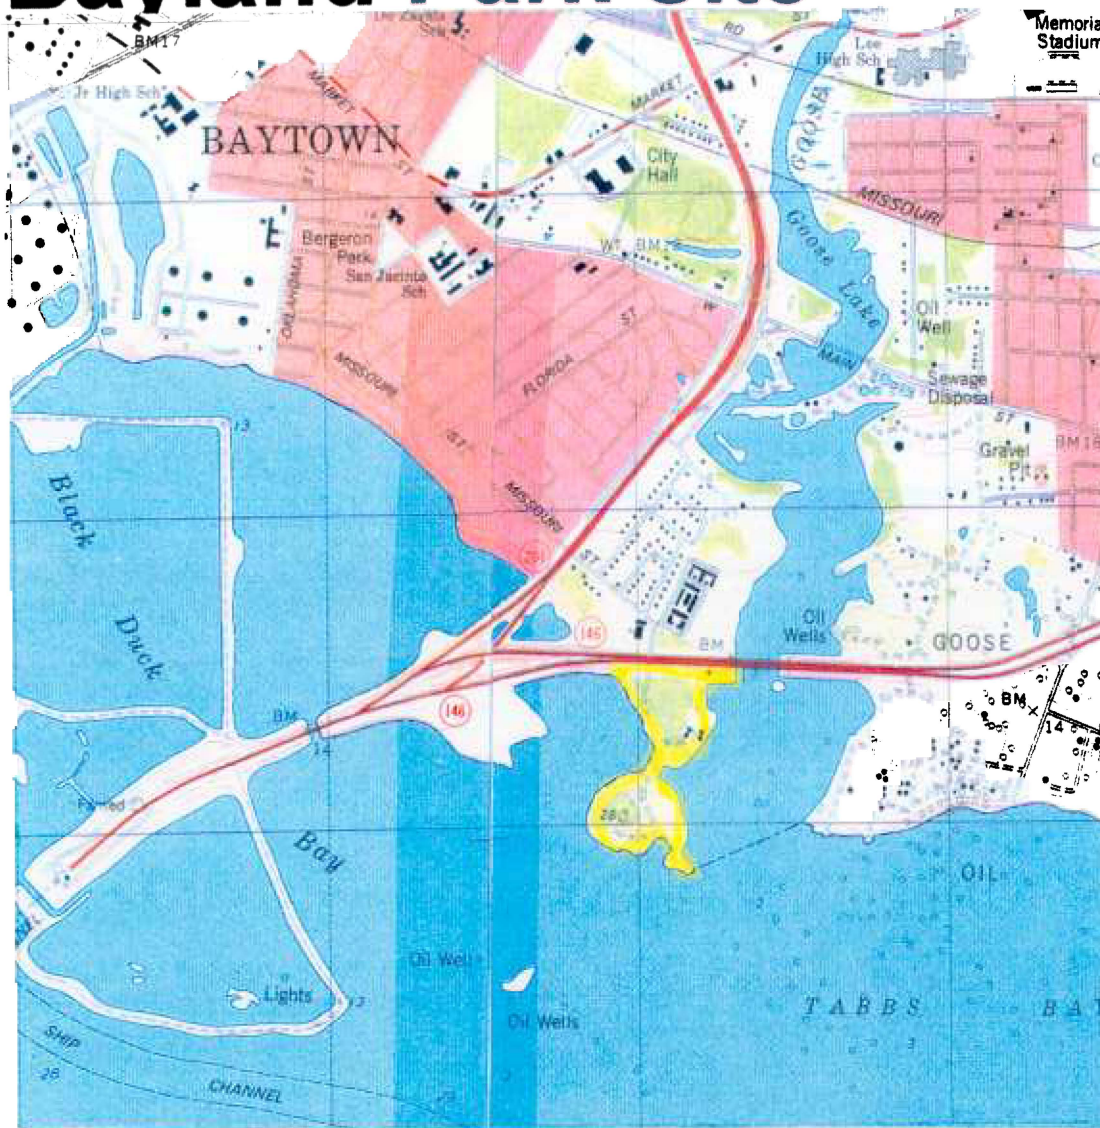
Bayland Park Site

Characteristics:

- City of Baytown park
- Good Public access
- Significant excavation required
- Looks intentionally built up through dredged spoil deposition
- Very limited possibilities

Both the Bayland Park and San Jacinto Inn sites appeared to have been significantly built up through dredged spoil deposition. The deposition alone is a negative factor, and that factor combined with high elevations requiring significant excavation caused these two sites to be eliminated.

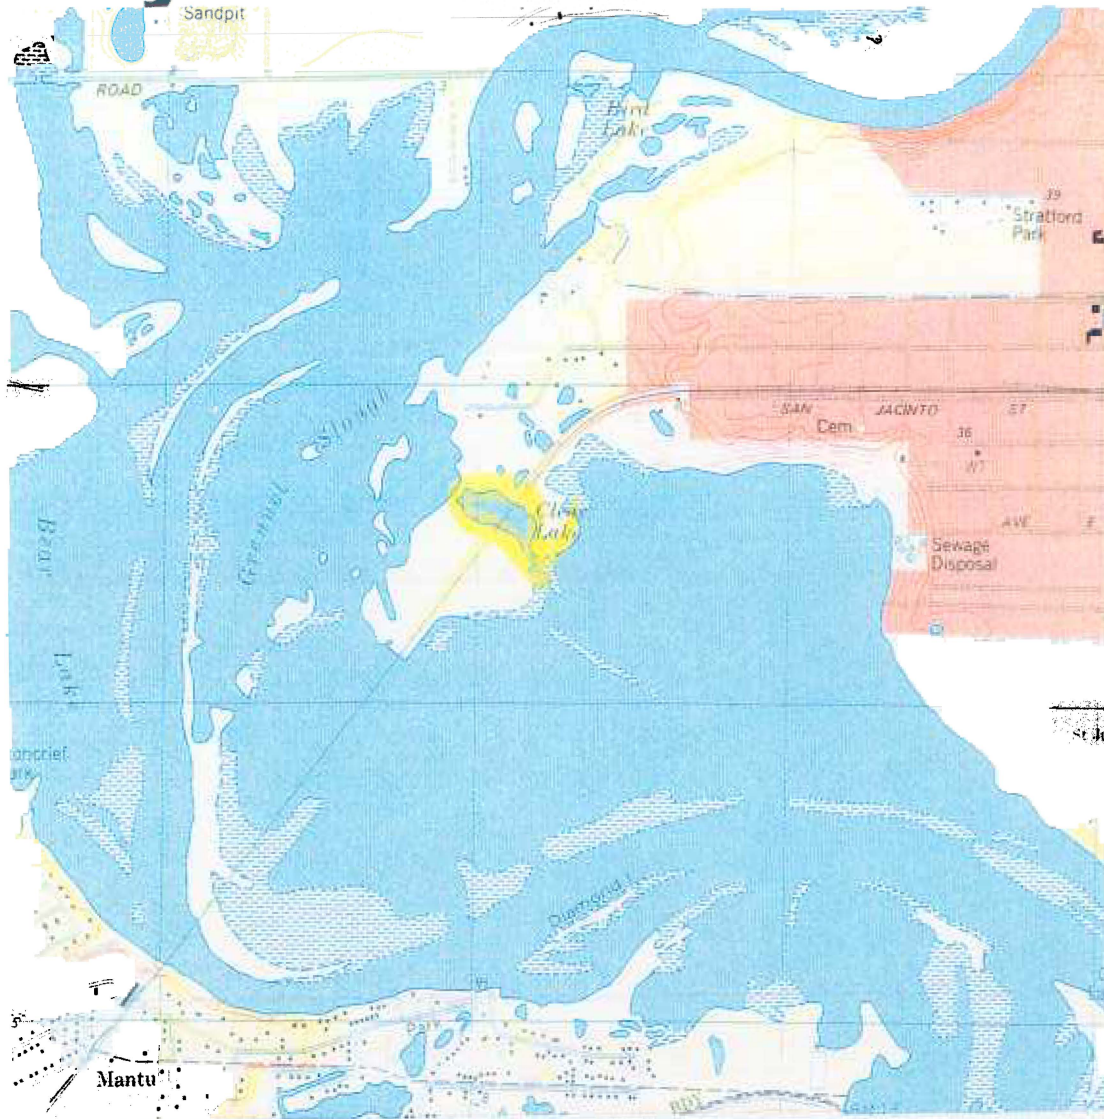
Baytown Boat Club Site

Characteristics:

**Existing quality
forested wetland**

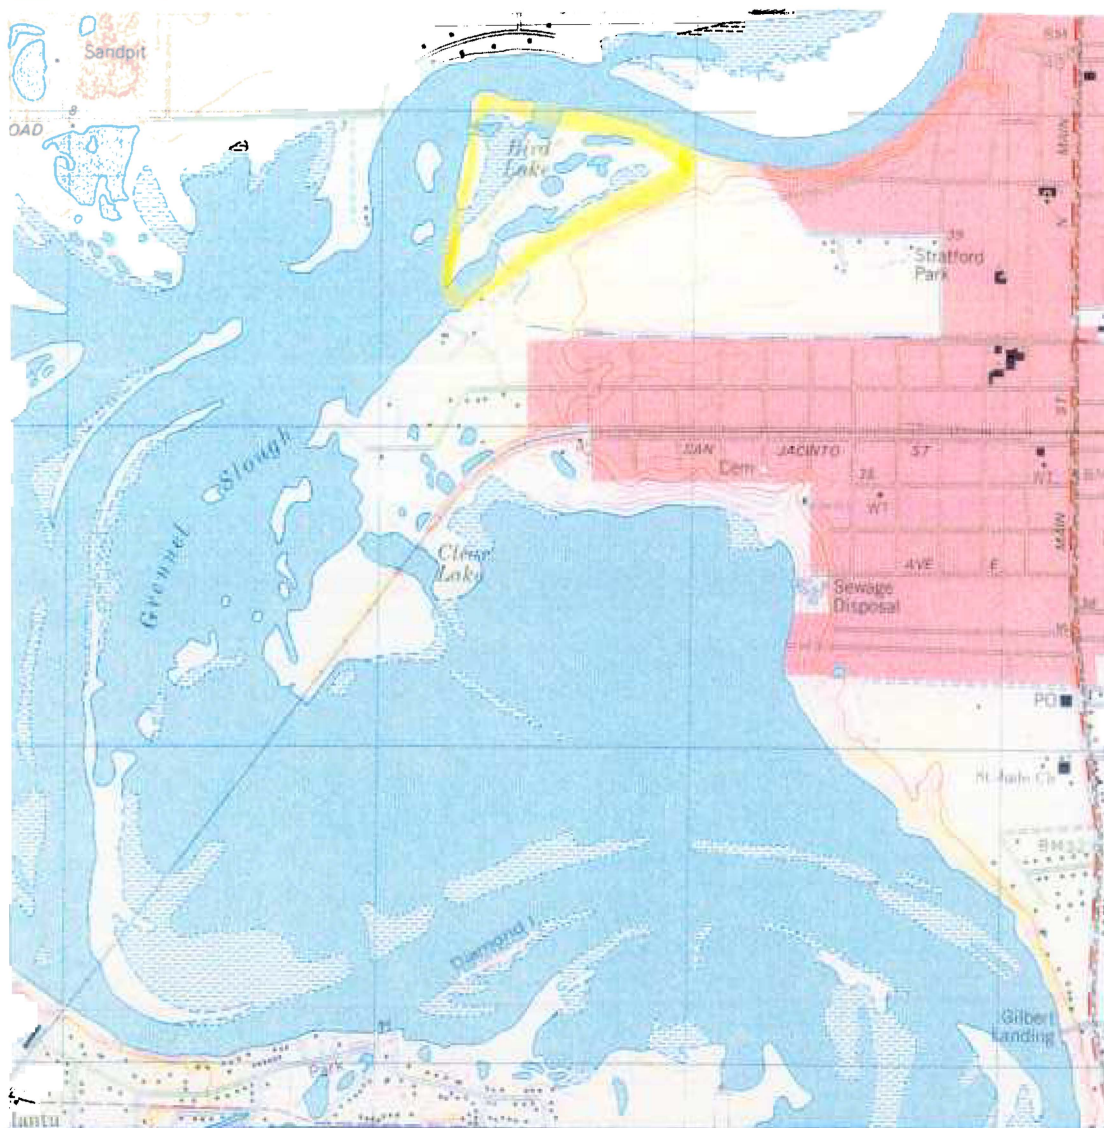
Bird Lake Site

Characteristics:

- Inaccessible by vehicle
- Existing quality wetland
- Expansion and enhancement possibilities limited

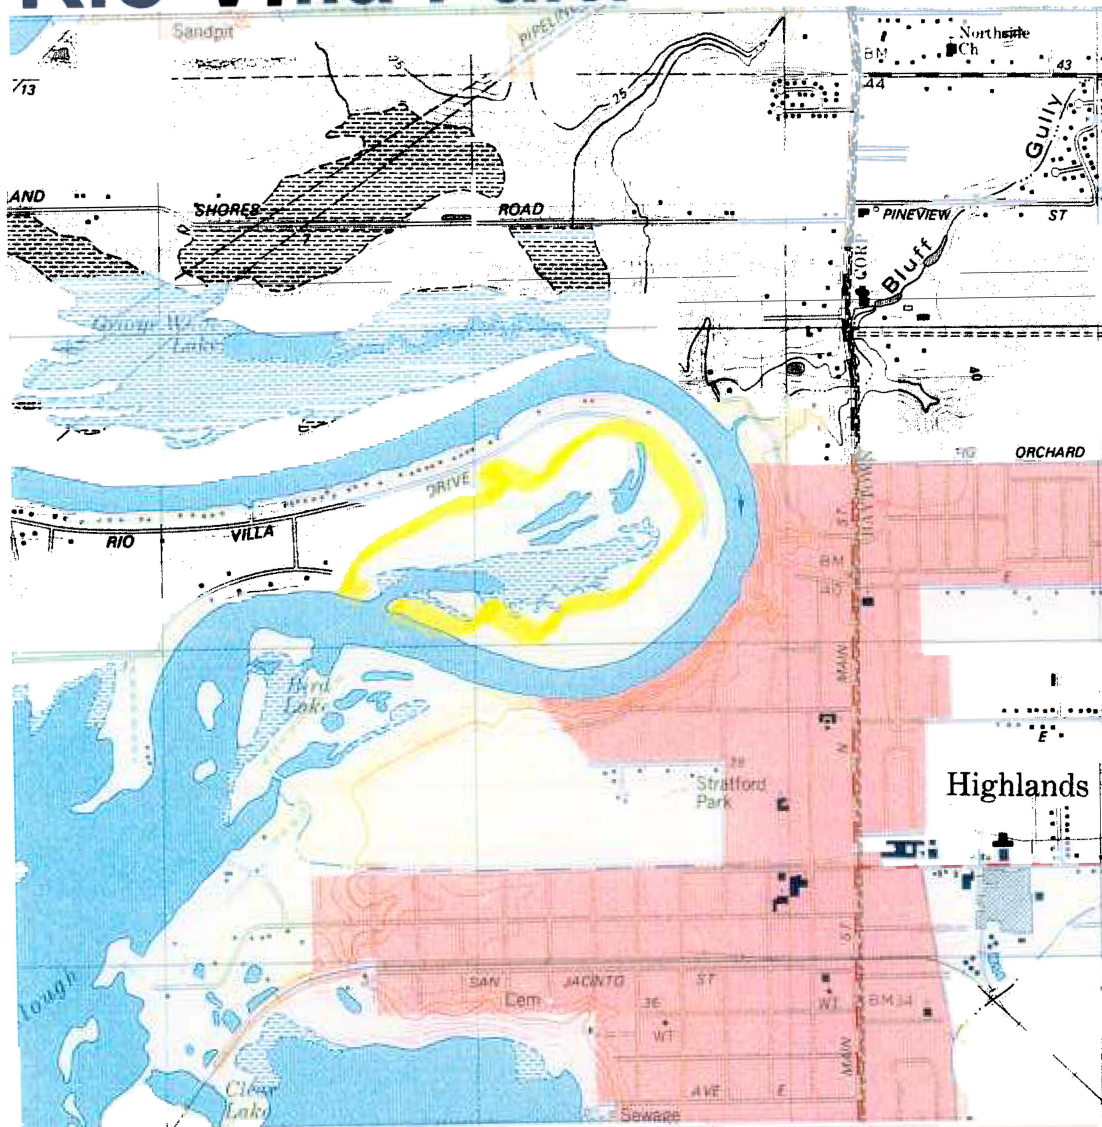
Rio Villa Park

Characteristics:

- Existing high quality fresh marsh and forest
- Limited Access
- Good Buffer
- Can enhance or expand
- Significant excavation
- Close to FL Site
- Low Wave Stress

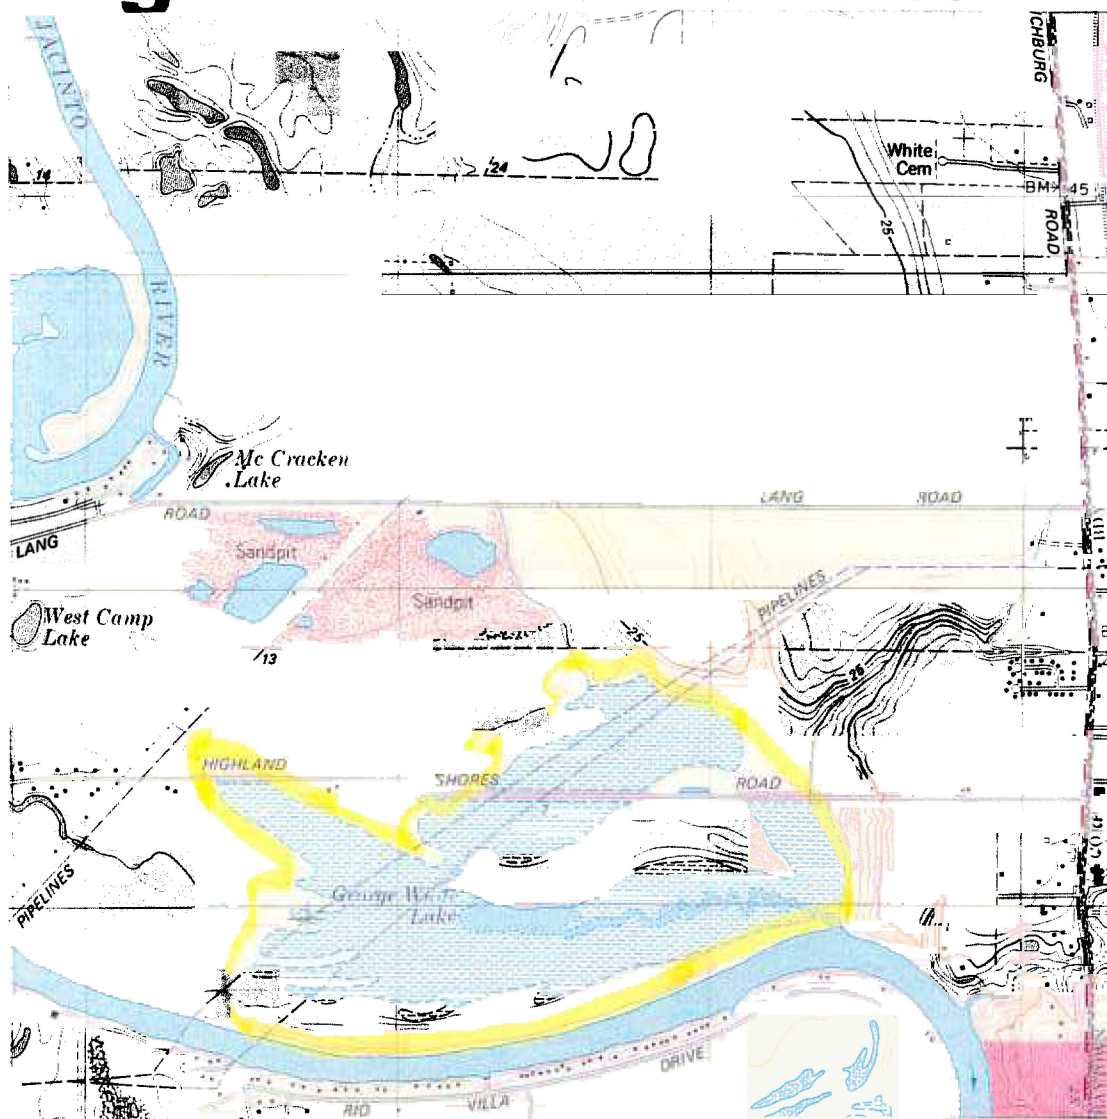
Highland Shores Site

Characteristics:

- Existing high quality fresh marsh and forested wetland
- Moderate access
- Good Buffer
- Could be enhanced

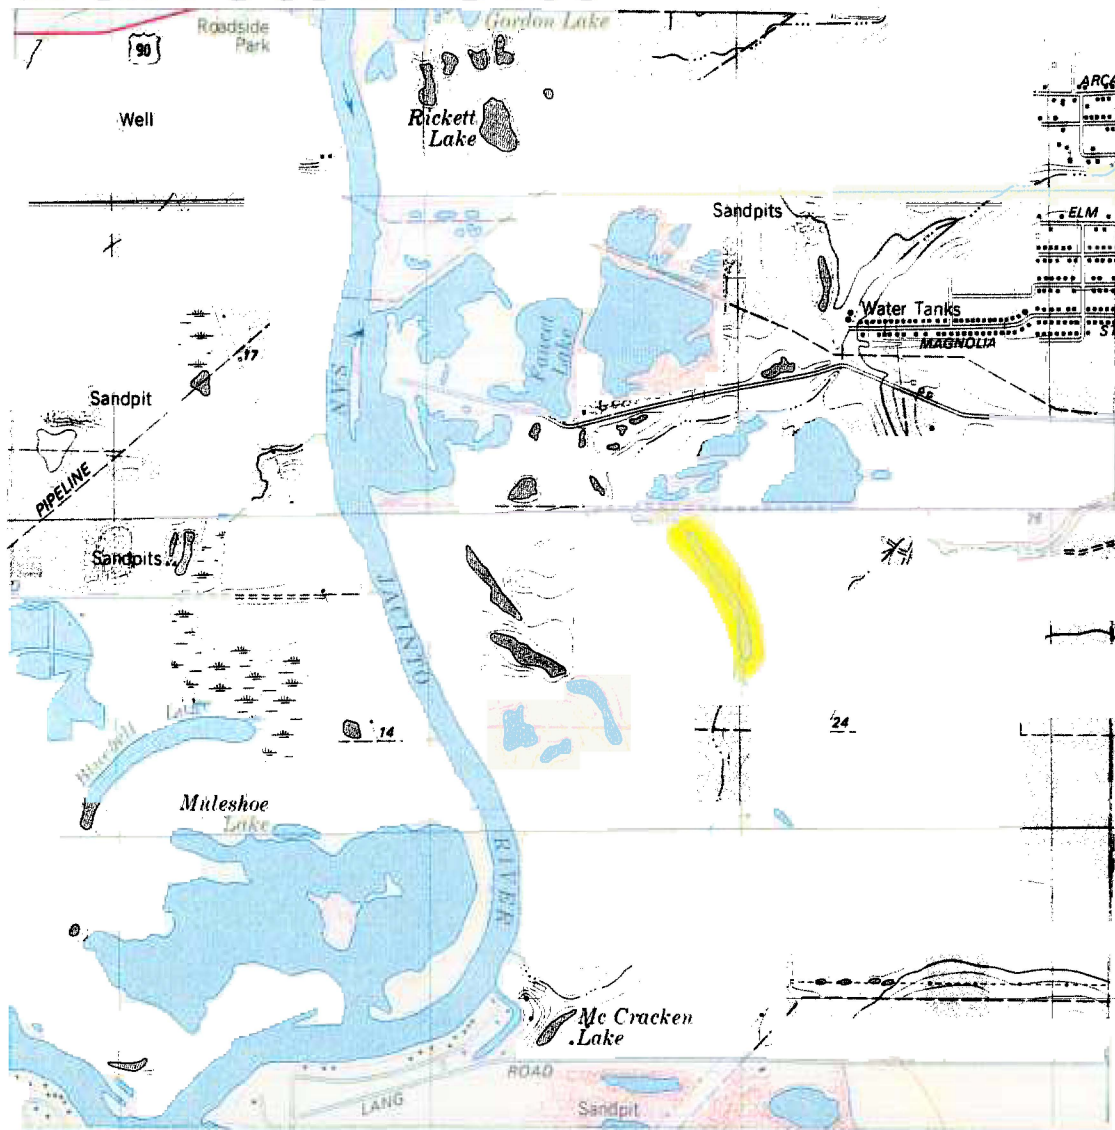
Barrett II Site

Characteristics:

- Poor access by private dirt road
- Existing fresh water wetland
- Could be expanded into adjacent pasture
- Currently well buffered
- Close to Barrett and FL Site
- Would be isolated fresh water w.l.

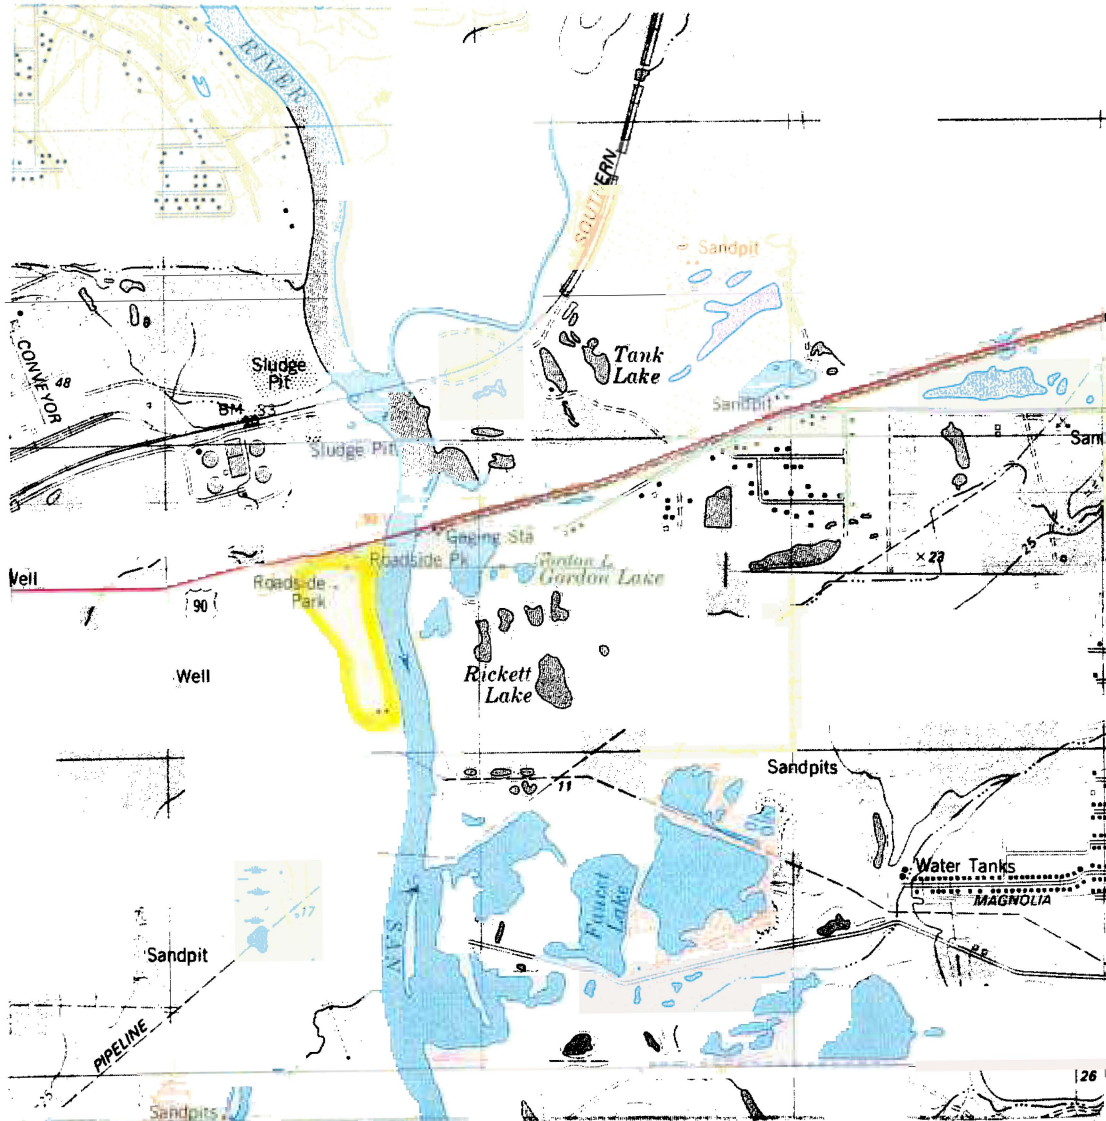
Old U.S. 90 Park Site

Characteristics:

- Pine-Hardwood forest
- No existing wetland
- Significant excavation required
- Utilized as local dump site
- Not a promising location

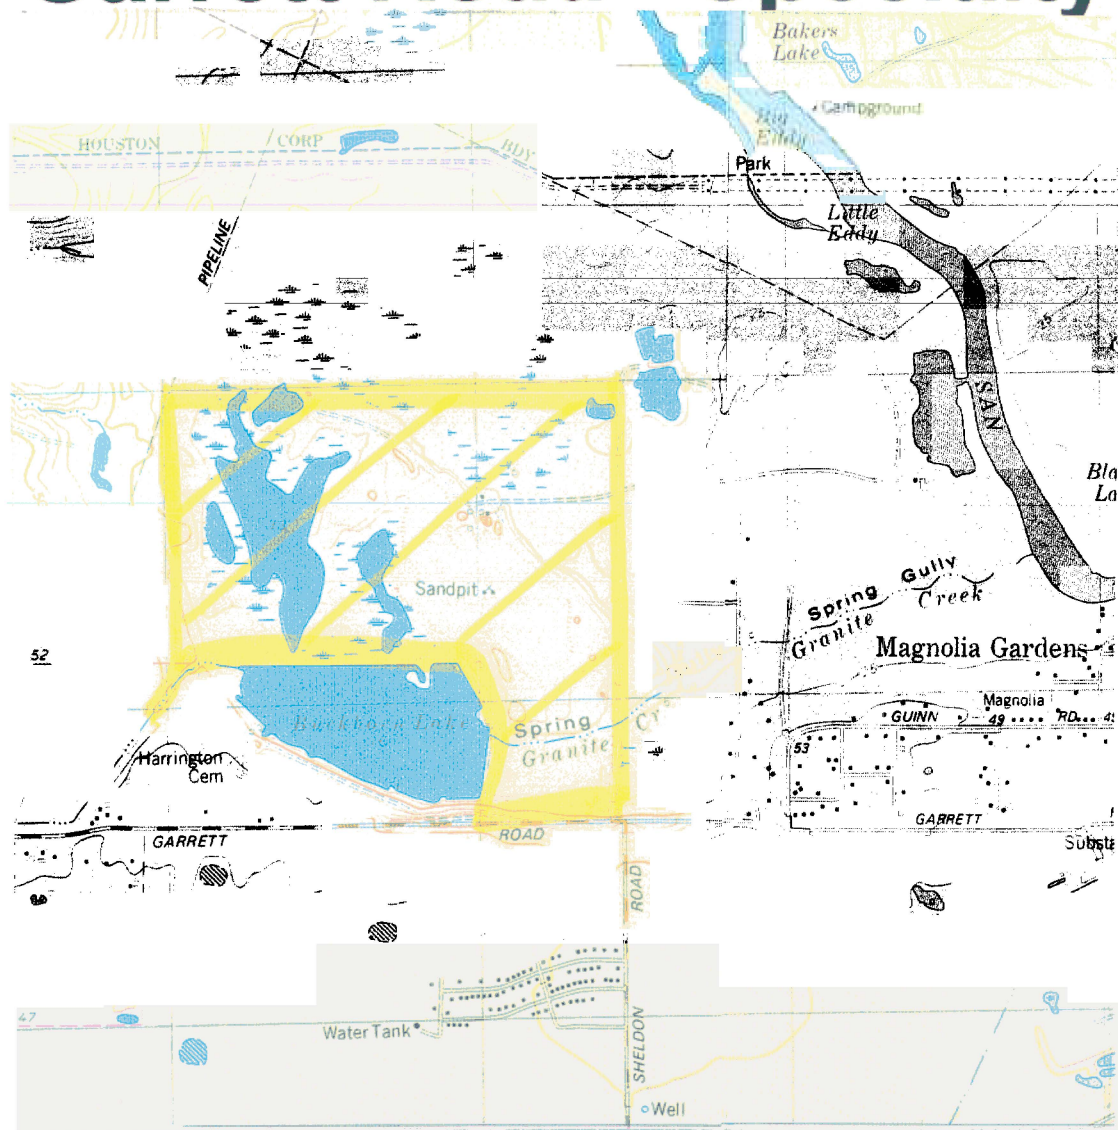
Garrett Road - Specialty Sand

Characteristics:

- **Extremely large area**
- **Existing fresh wetland areas could be easily expanded and/or enhanced**
- **Good buffer**
- **Inaccessible to public**
- **Wetlands would be isolated f.w.**

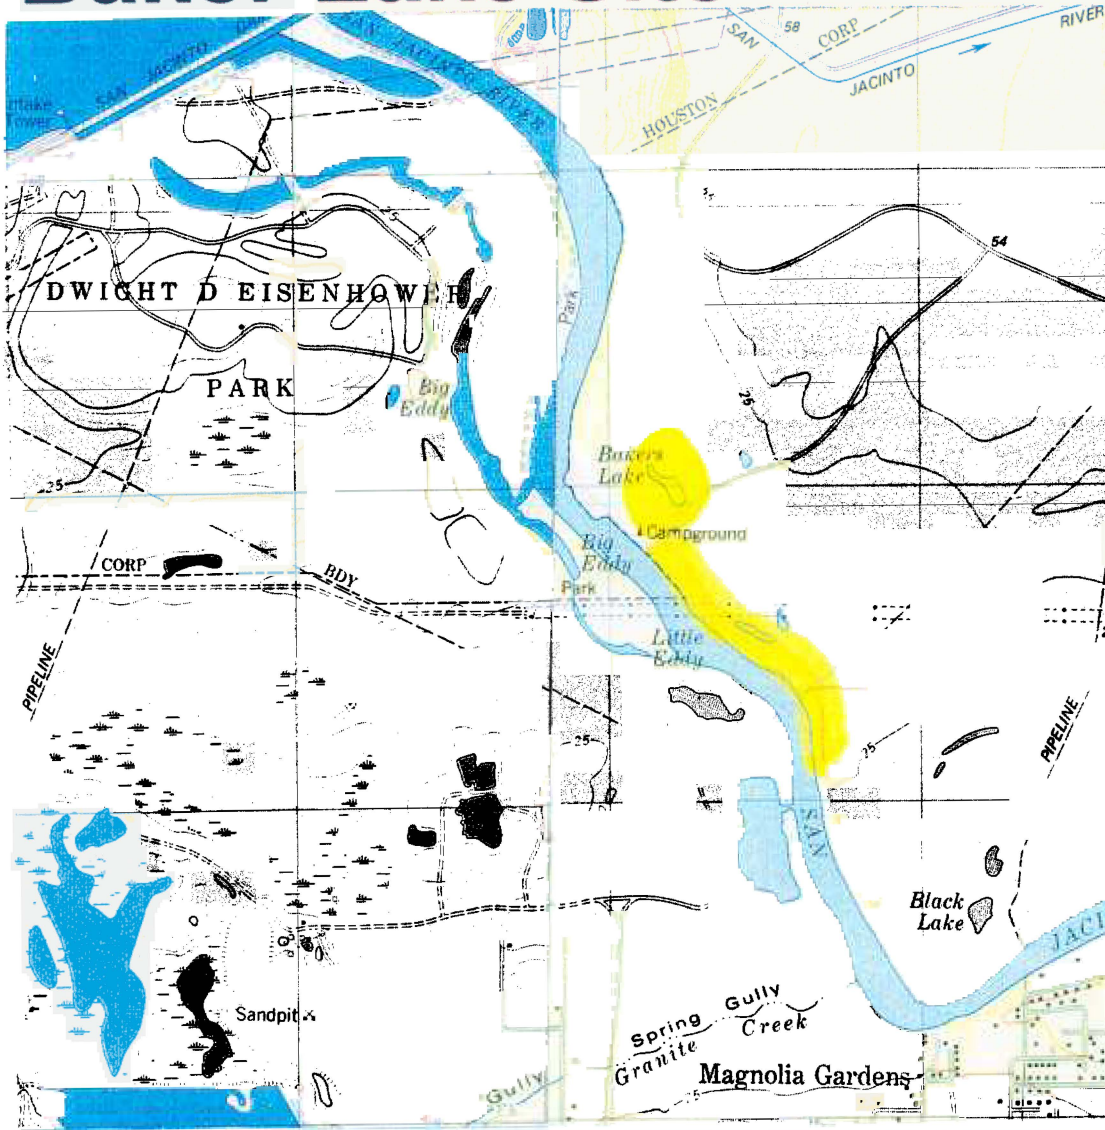
Baker Lake Site

Characteristics:

- Existing hardwood forest and cypress lake
- Easily accessible to public
- Could be expanded into fresh water marsh
- Significant excavation
- Part of Newport residential development

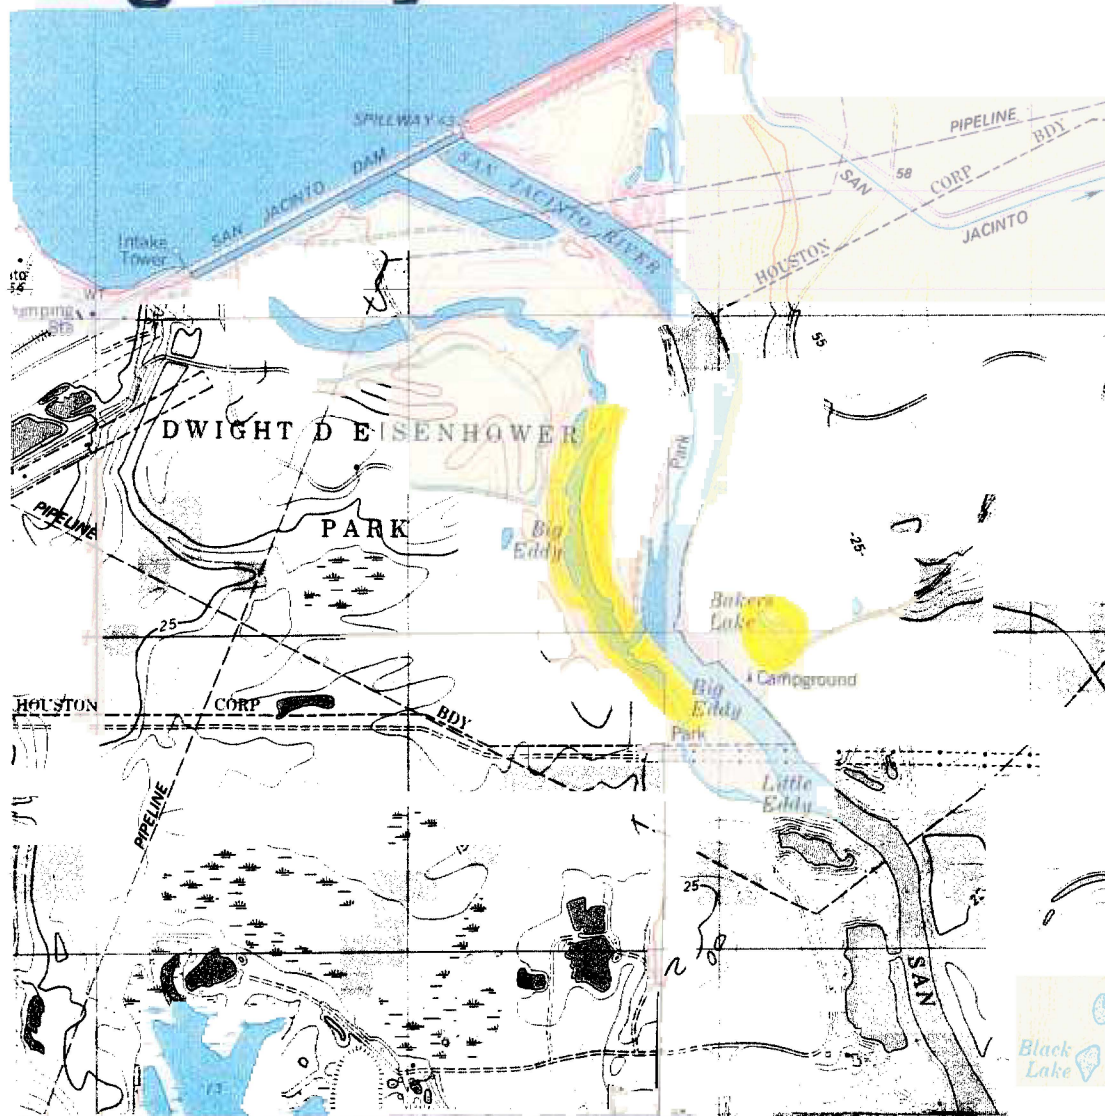
Big Eddy Site

Characteristics:

- Existing high quality cypress lake
- Northern end could be expanded
- Public access by boat from park on Lake Houston
- Noted significant vandalism in adjacent park
- Steep southern shoreline
